## **PORTA RÁPIDA DOMINÓ – AUTO REPARÁVEL**

## NEW DOMINO SELF-REPAIRING FAST ROLL-UP DOOR

**CAMPISA** manufactures roll-up and folding-up rapid doors since 1995, and has a market reputation for quality and absence of maintenance needs. To respond to the increasing requests of the market, and especially for Commercial Stores, a NEW DOMINO ROLL-UP DOOR has been conceived, with ultimate features.

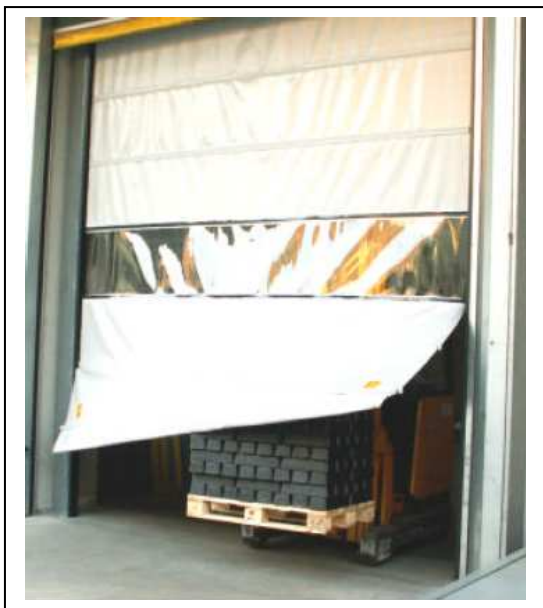
- Painel fabricado em poliéster, recoberto em PVC e reforçado – secções de 820mm.
- Painel em Polyester (ignífugo classe 2), disponível por pedido em várias cores para melhor acabamento.
- A opção standard já inclui uma secção transparente ao nível dos olhos – 1350mm até 2100mm
- Quadro de controlo electrónico com protecção IP65 e com botão de emergência.
- Velocidade 1 m/s
- Motor Trifásico – 0,5 KW – 1,4 A – 400V

- Caso se verifique alguma colisão do empilhador e/ou carga com o painel, ele não se danifica. O painel solta-se das guias laterais, voltando logo de seguida à sua posição normal pelo efeito da gravidade. No caso de impactos violentos pode ser necessário a intervenção humana.
- A parte do painel susceptível de sofrer danos é removível, sendo portanto facilmente substituída em caso de necessidade. Essa substituição pode ser facilmente executada pelo operador.
- Sistema inovador que vai ao encontro das necessidades do utilizador.

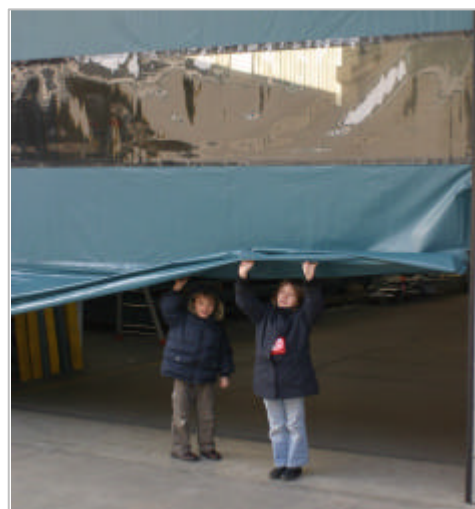
The mass descending on possible obstacles is so insignificant that there is no need of safety rib.

the average opening and closing speed is of 1 m/s. The special coat of new concept, included the elastic retention bars, may cause a chock of only 40 N in average against the possible obstacle, further distributed by the bottom soft edge. This modest

force, quite inferior to the maximum allowed impact of 400 N allowed by the European Standard EN 12453, does not constitute a risk to be protected by a safety rib, that is the cause of most damages to the doors.
